Re: Clean Water Act Compliance Evaluation Inspection at P&L Doornenbal Dairy located at 13146 Galloway Road in Caldwell, Idaho.

IDAHO CAFO INSPECTION REPORT

Idaho CAFO Inspection – Photograph Log: P&L Doornenbal Dairy

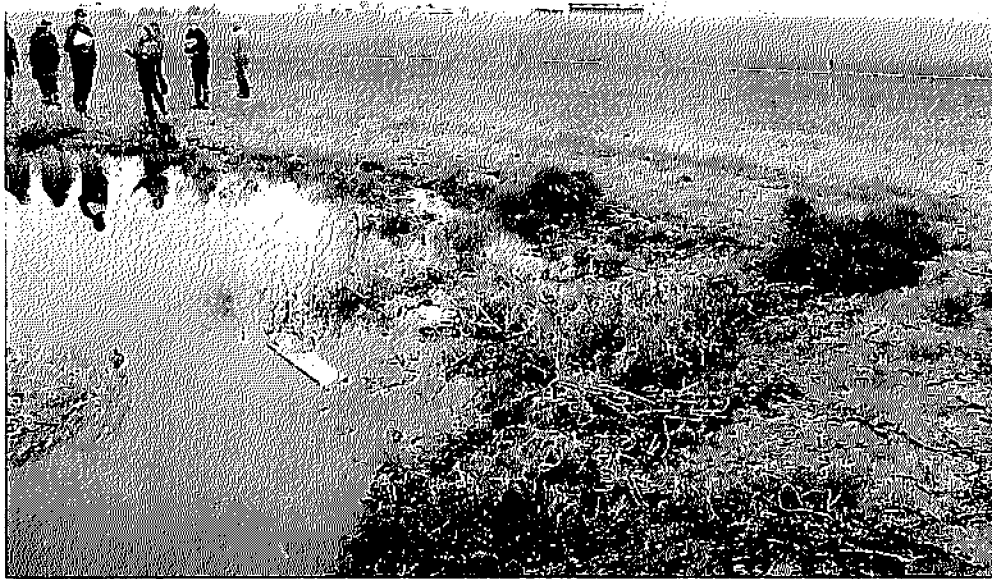
- During the site tour, the inspectors observed that minimal freeboard (2-3 inches) was available in the northwest corner of the Northwest Evaporation Pond (Photograph 1). An overflow of wastewater from this location would flow into the adjacent field. It is recommended that the facility pump down the lagoon to maintain at least two feet of freeboard.

Although the facility's NMP indicated a surplus of storage capacity to contain manure and process wastewater, site observations indicated inadequate capacity. The Northwest Evaporation Pond had minimal freeboard (Photograph 1) and there had been a recent overflow from the Concrete West Slurry Pit. According to Mr. Doornenbal and based on site observation, the spill did not reach the end of the field (Photograph 2).

Photograph 1. Minimal freeboard was observed at the northwest corner of the Northwest Evaporation Pond. View looking southwest from the northwest corner of the Northwest Evaporation Pond.

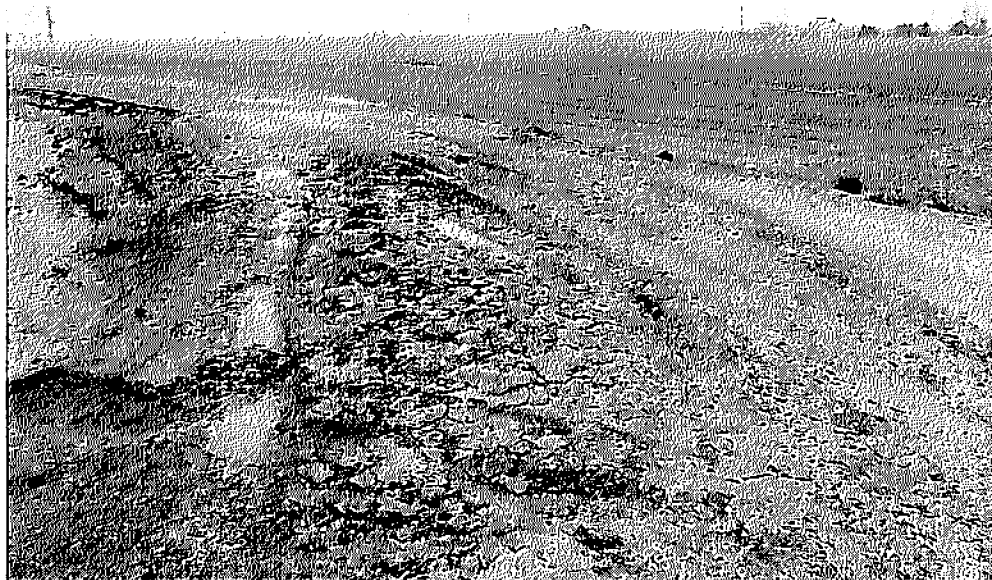
- According to the facility representative, the facility had an overflow of approximately 1,000 gallons from the Concrete West Slurry Pit approximately two weeks before the inspection. The inspectors observed that the overflow entered an adjacent field which is owned by Doornenbal Dairy and leased to a third party (Photograph 2). The facility representative did not notify ISDA of the overflow and did not have records onsite documenting the overflow. It is recommended that the facility notify ISDA and maintain documentation onsite of any overflows in the future.

According to Mr. Doornenbal, an estimated 1,000 gallons of manure slurry overflowed from the dairy's Concrete West Slurry Pit into the adjacent field approximately two weeks before the inspection. The inspectors observed evidence of the overflow (Photograph 2). Mr. Doornenbal did not document the date, time, and estimated volume of the overflow. This documentation is not required for unpermitted CAFOs under the Clean Water Act. Note, however, that any overflow resulting in a discharge to Waters of the U.S. from an unpermitted CAFO is a violation of the Clean Water Act. Mr. Doornenbal also did not report the unauthorized release to ISDA, as required by ISDA's Rules Governing Dairy Byproduct.

Photograph 2. The inspectors observed evidence of an overflow from the Concrete West Slurry Pit. View looking southwest from the northwest corner of the Concrete West Slurry Pit.
